Navajo Abandoned Uranium Mine

Site Screen Report

Pat Lynch AUM Site

January 2011

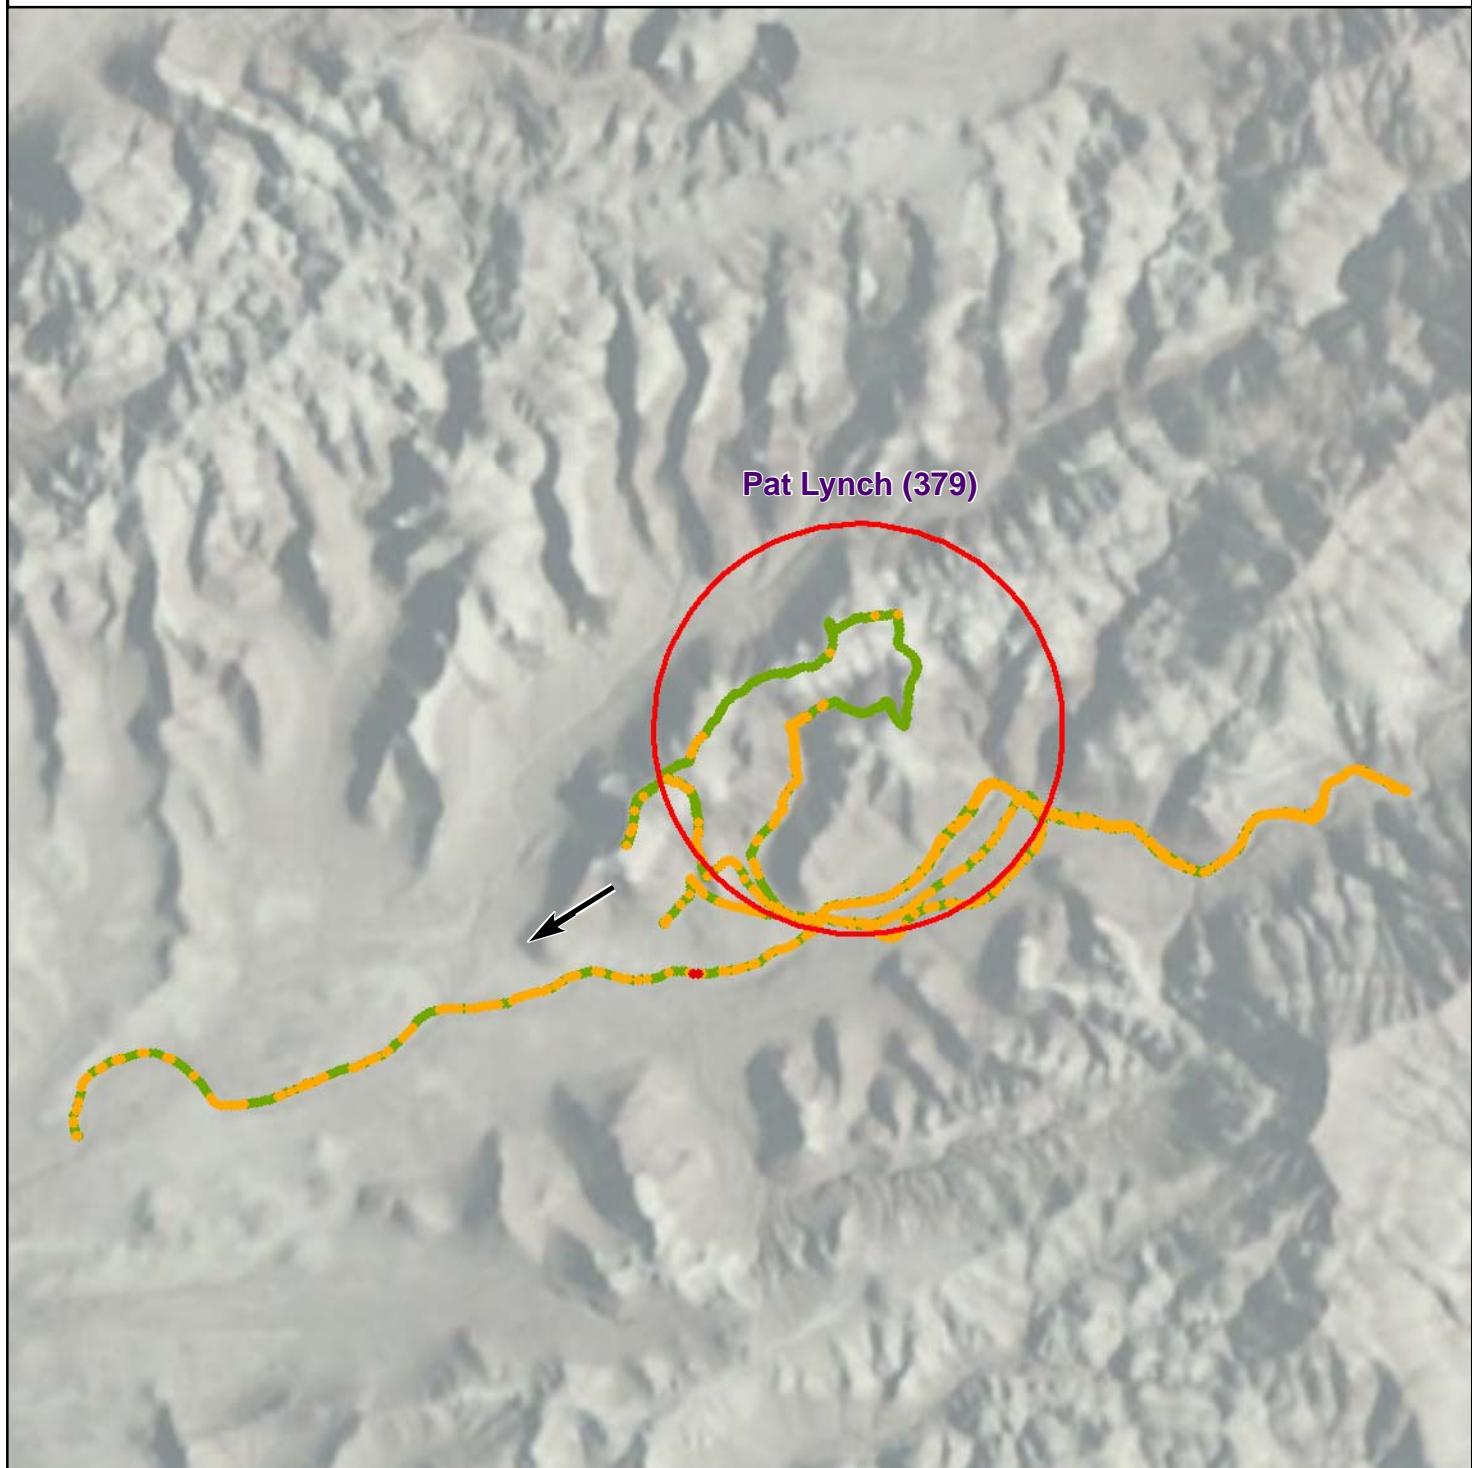
Figure 1 - Gamma Radiation Measurements, Above Two Times
Pat Lynch (379)
Coalmine Mesa Chapter, Navajo Nation

A total of 1,679 gamma radiation measurements were collected from the mine site, ranging from 9,640 cpm to 22,069 cpm. The measurements are represented in Figures 1 and 2.

Gamma survey conducted 11/2010
Measured as counts per minute (cpm)

Average background 15,788 cpm
